Appendix 1

Individual Park Assessments

A1.1 Neighborhood Parks

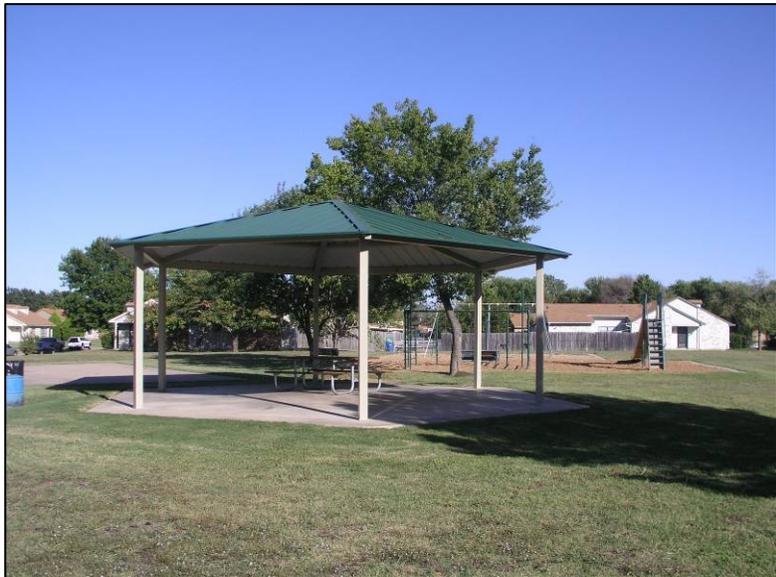
Comments – This park primarily is composed of un-programmed space surrounding a playground / pavilion / basketball court complex. The play equipment in the park is aged, yet the pavilion is new. The park feels very open because of the large amount of un-programmed space and sparse tree vegetation, yet the single-loaded roads with houses facing on the opposite side help to define the edges of the park. The pavilion – having only one table – is mostly underutilized.

- Sidewalks from Carr and Chapman streets should be extended, through the park, to the intersection.

- An additional table should be installed in the pavilion and seat walls should be placed along the pavilions edge to serve as additional seating for picnics and for watching basketball.
- Consider replacing the pavilion roof with a multi-tiered roof in order to prevent the build-up of heat which can render the pavilion unusable.
- Extend electrical service and lighting to the pavilion in order to increase demand for pavilion rentals and to increase perceived safety within the park at night.

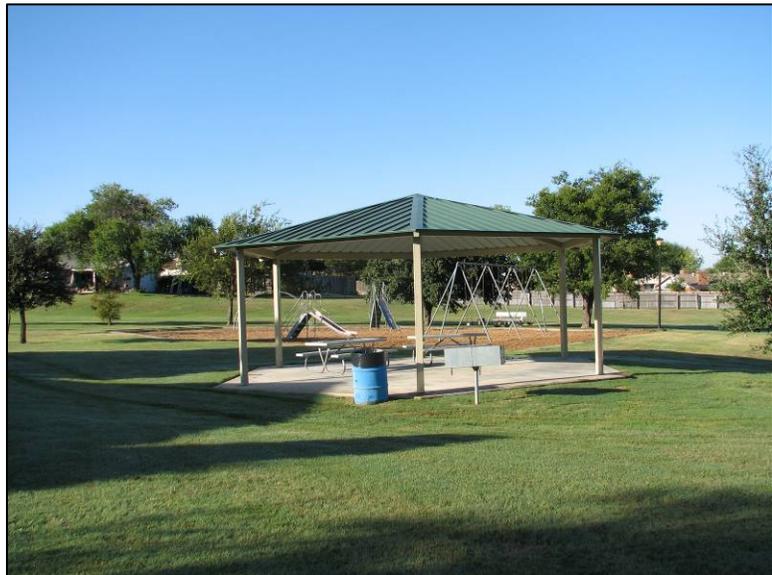
Comments – Dave Cowan Park is located in an attractive and unique setting; the varied topography, which slopes gradually from south to north, the adjacency of single-loaded roads and houses with open fences (rather than stockade fences), and the view to the creek corridor to the north create a visually interesting backdrop for the park. Additionally, because the

northern border of the park is longer than the southern border, the space that the park occupies acts as a visual gateway to the Corp of Engineers floodplain land beyond the park.

Though there are these many positive features, this park does not present a sense of organization. Specifically, access to the varied areas of the park is not clearly defined through sidewalks or paths. In addition to making many of the park's amenities non-accessible for the disabled, this presents a feeling that the playground, pavilion, and volleyball court were positioned in the park randomly. Further adding to this sense of disorganization, the trees within the park were not planted in a logical or natural manner; rather, in many instances they were planted in straight lines in the middle of a large open space. Typically, for aesthetic reasons in parks, trees are either planted in clusters or, if planted in straight lines, are planted along a fence, street, promenade, or some other linear feature.

- Design and construct a network of accessible sidewalks that connect each of the park's main programmed spaces to help build coherency within the park.
- Renovate or replace the aging playground equipment, replace the gravel in the playground with an accessible and safer material such as wood fiber, and ensure that vegetation does not encroach on the playground area.

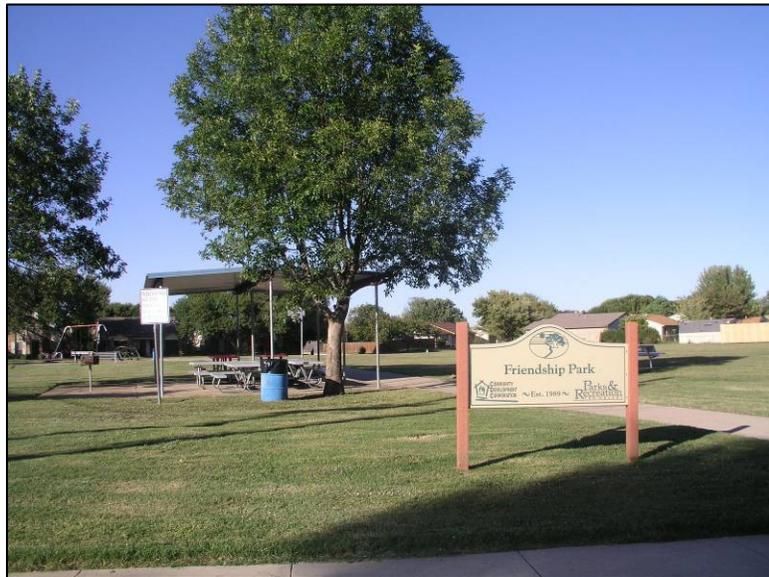
Comments – Friendship Park occupies a large, easily accessible parcel of land bordered by three single-loaded streets (Malone Avenue, Newton Street, and Keys Lane) and, on two sides, by houses. While the park enjoys a large amount of available land, it lacks a sense of organization or “place” owing partly to the arrangement of its amenities and a scarcity of trees and shrubbery which

leads to a feeling of vastness and emptiness. In some instances, the proximity of houses helps to appease this empty feeling; specifically, one house does not have a fence around its backyard, which helps make the park feel more open and less like a canyon. However, because of its accessibility, its proximity to many houses and two schools, and the possibility for pedestrian connections between neighborhoods, Friendship Park is an important part in The Colony’s park system.

Much improvement could be made to this park with updating and repairing its amenities (new playground equipment and repair or removal of tether ball pole) and adding trees and/or shrubs to help define edges and spaces within the park.

- Play equipment is aged and outdated. Some of it should be removed and replaced with a different type of equipment (i.e., merry-go-round) and some should be repaired and refurbished.
- The pavilion should be updated to be more inviting. Ways to accomplish this include removing some of the picnic tables and locating them under nearby shade trees, repairing cracked pavement, replacing the aging BBQ grill, and replacing the pavilion covering with a more effective two-tiered design.

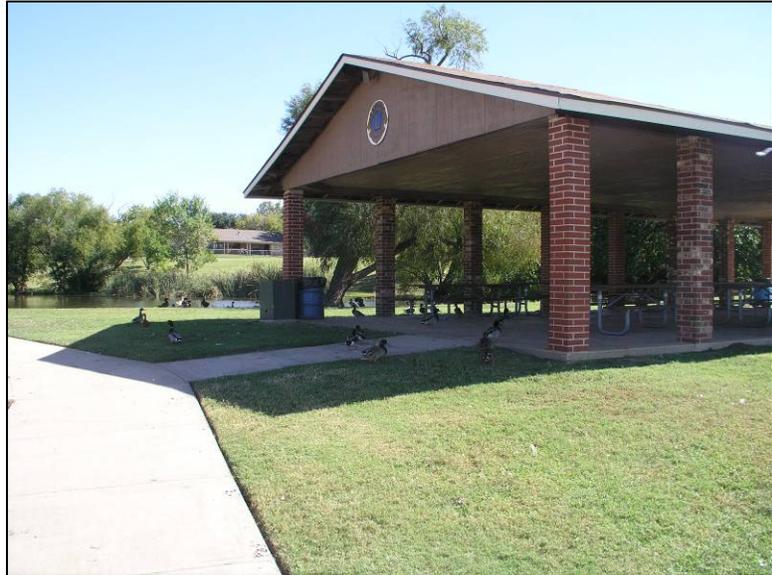
Comments – The effectiveness of this park as an open space within a neighborhood is enhanced by the adjacency of single-loaded roads and open fences surrounding the park. The established, mature trees surrounding the pond provide shade and visual interest in the park and present interesting spaces within the pond area. One characteristic that one cannot ignore when visiting this park is

the large number of ducks and geese that are always present here. This adds a unique characteristic to the park, but also results in the area surrounding the pond being covered in feathers and feces. Specifically, the pavilion is ailed by this condition which, no doubt, decreases the demand for its use by the general population. Taking measures to keep the pavilion clean will improve its demand for rentals.

- The white rock parking lot should be replaced with a paved parking lot.
- There is currently a chemical toilet in the park. If restroom facilities are needed in this park, the chemical toilet should be replaced with a permanent, more aesthetically pleasing restroom facility.

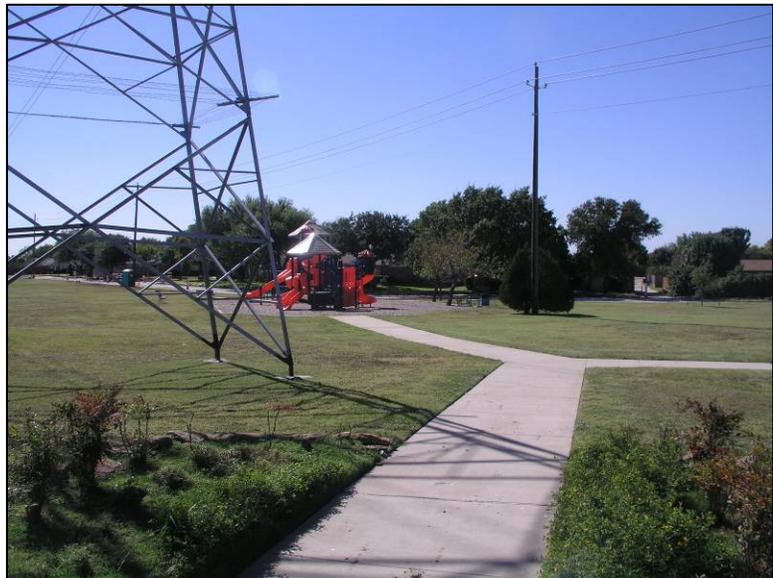
Comments – Perryman Park is one of four parks located at the intersection of South Colony Boulevard and Blair Oaks Drive. Because of its proximity to these two rather busy streets, this park takes on a different character than is typical for a neighborhood park (as do the other three parks at this intersection). Much of this park is located underneath the large power transmission lines that cross the city, which also affects the park’s character.

Present in the park is very modern playground equipment that is designed for a range of children ages, which is an advantage as this park is located so closely to Camey

Elementary which occasionally uses this park². In addition, the Education Center Charter School also uses this park on occasion because of its high-quality playground equipment. Finally, the park is largely compliant with ADA accessibility guidelines (except for the parking lot) which enhances the park's sense of continuity and organization.

- This park considerably lacks support facilities. Specifically, the park would benefit greatly from the addition of shade structures, benches, a drinking fountain, and a restroom. These items were mentioned by users from the elementary and charter schools as needed at this park during a field visit.
- The parking lot is not well-defined and is unpaved. It is recommended that the lot be paved and striped; paving this parking lot will also allow it to become ADA-compliant.
- The pavilion in this park is quite aged and should be renovated or replaced.

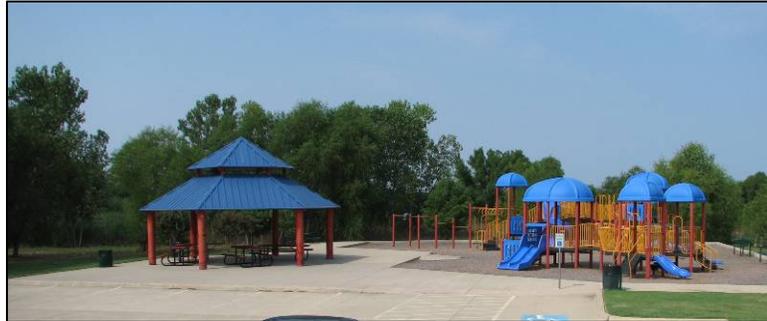
Comments – Ridgepoint Park has one of the most beautiful settings of all the parks in The Colony – it is at the end of a single-loaded road, near the shoreline of Lake Lewisville, and is surrounded by riparian

vegetation including cottonwoods, willows, and bald cypresses. Currently, only a portion of the park is developed, but across the site different experiences are provided by the changes in terrain and a line of trees that divide the park in two.

One portion of the park (which contains the pavilion and playground – both of which are state of the art and ADA accessible) has a very calm feeling to it. This area feels like a room within the park that is enclosed by the surrounding trees. There are sounds of cottonwoods blowing in the wind and occasional motor boats passing by. The other portion of the park has a much more expansive feeling, has great views of the lake, and is bordered on one side by houses with open fences. This portion is also much windier, but is still relaxing.

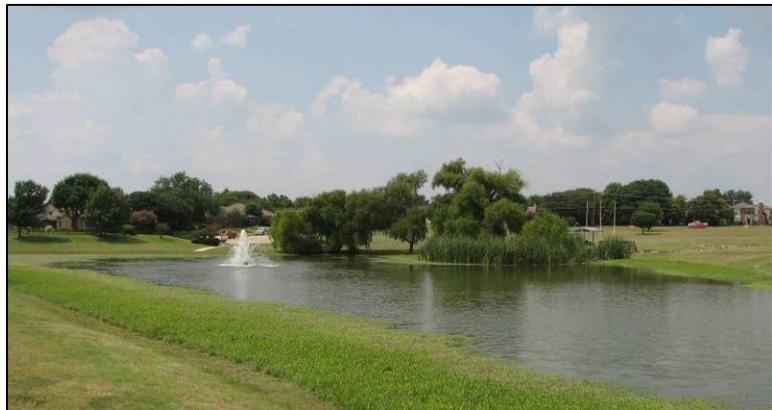
Comments – Scout Park is unique in that it is the only neighborhood park in The Colony bordered by houses facing the park *and* the shoreline. Additionally, North Colony Boulevard – a main collector street through this part of the city – runs along the edge of the park opposite the lakeshore. Considering all of these factors, this supports Scout Park as being a prime gateway from the city to the lake, both visually and physically as the future Shoreline Trail will pass by Scout Park.

The focal point of the park is clearly the pond with the water fountain, waterfowl, and aquatic plant species. The strength of this focal point is fortified by the topography within the park which slopes down toward the pond like a bowl. Because of the lack of fences bordering the park, Scout Park has a feeling of being one of the most inviting and accessible parks in the city – a feeling which will only increase once the Shoreline Trail is completed.

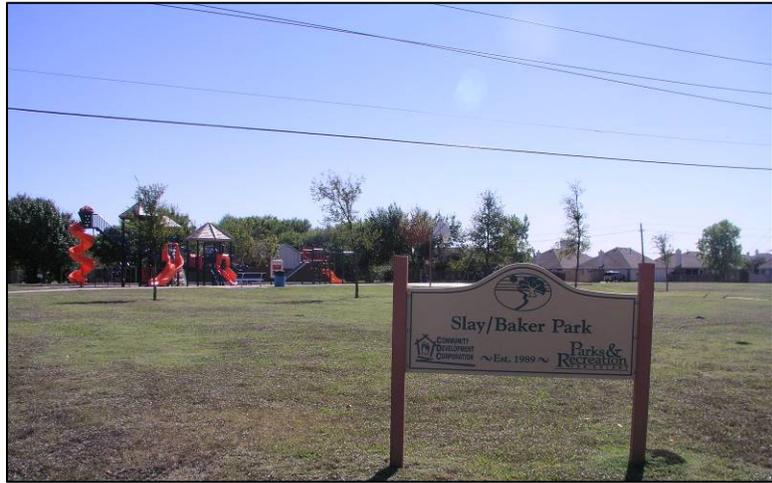
Comments – This park, while relatively undeveloped, enjoys a prime location along one of the city’s two utility easement corridors. In its current state, the park has a modern playground and a basketball half court – both of which are ADA-accessible – and a large amount of open space. In addition to the utility easement, the park is surrounded by single-loaded streets, the sides and backs of houses (some with open fences), and an alleyway.

Currently, the park contains few trees, only one of which is mature, and is visually marred by the power lines which pass through the park. Because of its location and adjacency to the utility easement, this park could serve as a trailhead, neighborhood gateway, and a major node along the planned Park Loop Trail³.

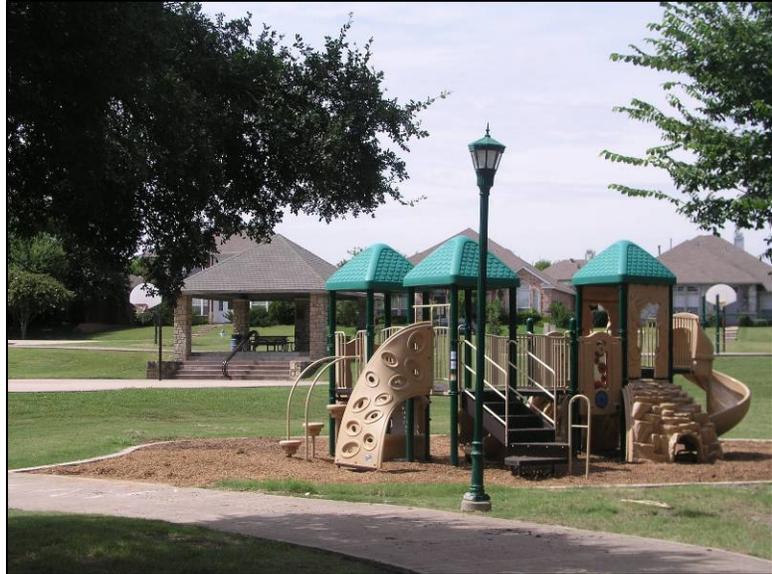
Comments – Bill Allen Memorial Park is one of the most diverse and visually appealing parks in The Colony. It contains many amenities, including a nine-hole disc golf course, an amphitheater, trails, picnic areas, a playground, a basketball court, a pavilion, and an exercise area designed specifically for those with physical disabilities. The park also benefits from established trees, varied topography, and a creek corridor running through the middle of the park.

The park is surrounded by single-loaded roads on three sides, houses, and a railroad track. The creek divides the park into two zones – one with the disc golf course, picnic areas, and most of the other park amenities and one with the amphitheater, a pond, and a large, open, un-programmed field.

- This park is prone to flooding as was evidenced by the damage – especially to the playground – seen in the fall of 2007. Special considerations for this situation should be made; in addition to ensuring that permanent damage to amenities does not result from minor flooding, minimum chemicals for landscaping, cleaning, or repair should be used as these chemicals will easily enter the creek during a flood event, therefore entering The Colony’s drinking water supply. Additionally, flood-proof trash receptacles should be used for the same reason.

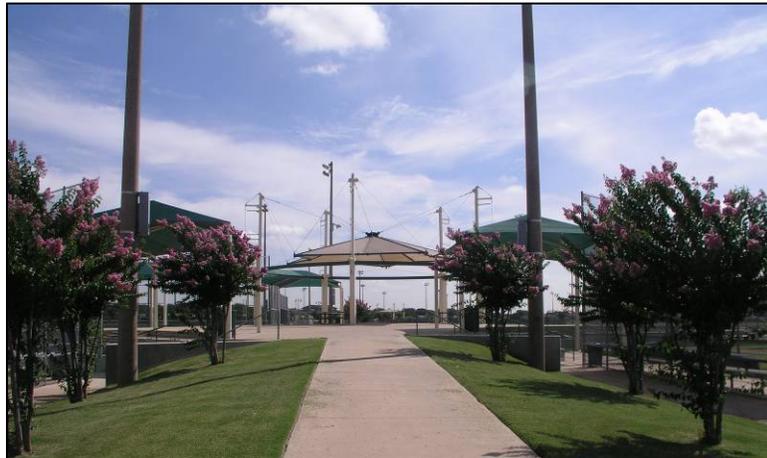
Comments – This park is the crown jewel of The Colony’s athletic recreation system. It is one of the best maintained and most expansive parks of its kind in the region. In addition to providing fifteen lighted playing fields of various types suitable for league use, this park also has a 1.2 mile walking trail that loops around the fields, playgrounds, and a veterans’ memorial.

- Across the entire site, the turf grasses are heavily mowed. On the date of the site visit, maintenance workers were mowing areas that appeared to have been mowed only days earlier (this includes non-playing field areas such as drainage ways and space between fields). This practice reduces the amount of moisture that the grasses hold, demanding more irrigation than would be needed if the grass was allowed to grow longer. Also, the amount of emissions from the mowers is greatly increased due to this extra mowing.
- Develop and implement a planting plan whereby native grasses are established in unused areas so that mowing is limited to the minimum necessary.

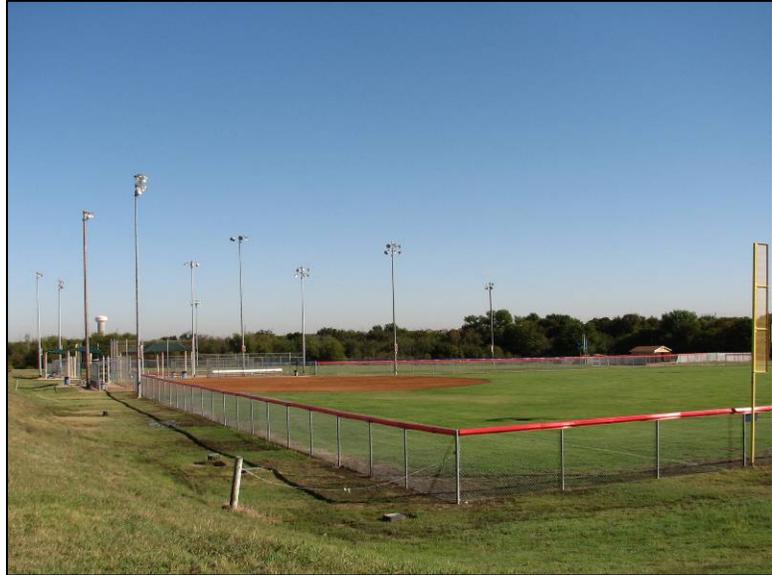
Comments – The adult softball fields in this park are very well maintained – second only in quality to the baseball fields at Five Star. The park also enjoys proximity to a school yard, a wooded area, and a single-loaded road, all of which add to the park’s visibility and visual character. There is a laser tag facility located in the wooded east end of the park that contains a series of trails, wooden

barricades, watch towers, and ponds. Paintball is specifically restricted at this location, but there are obvious signs that use of paintball guns does occur in this area.

The primary issues with this park are the location of the service facility on site and the under-use of the wooded edge of the park. The culmination of these conditions is that brush, logs, and unused supplies are piled in front of the wooded edge making this area look unsightly.

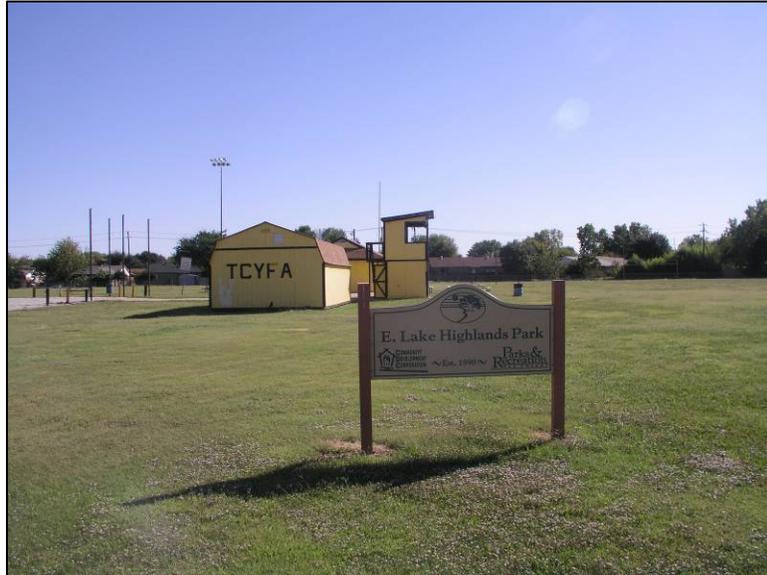
Comments – This park is hidden from general view as it is located between a residential area on two sides, a wooded creek area, and the City Public Works facility. The site feels enclosed due to the surrounding backs of houses with stockade fences (facing two sides of the site) and the dense wooded edge (facing one side). That is, three of the sides of the park area are bordered by a hard,

visually-impenetrable edge. In addition, the side of the public works facility facing the park is a work yard with outdoor storage and gravel piles. These areas are decidedly industrial in use, which differs from the nature of the park, the wooded edge, and the surrounding neighborhoods. As such, this park also functions as a buffer between the neighborhoods and the public works facility. Of note is that the public works facility is in the process of being expanded. As such, one of the two football fields at this park will be removed to accommodate this expansion. The amenities in the East Lake Highlands Football Facility, including the storage shed and bleachers, are showing their age. The culmination of the location of this park, its adjacencies, and the condition of its amenities tend to make it feel uninviting.

- The amenities on the site should be renovated – this includes the, storage shed, and concession / bathroom building. Each of these should be repaired and repainted as needed.
- Bleachers should be sheltered from the sun and the wind as applicable to enhance spectator enjoyment.
- The Parking lot needs to be more defined, preferably through permeable pavement and striping.
- Views of the public works facility’s work yard and gravel piles from the park should be screened through the use of vegetation or non-transparent fencing

- The lighting for the lighted football field could be considered invasive by the surrounding neighborhood. Lighting should be updated in such a manner that the light is focused down toward the ground by means of full cut-off devices, rather than dispersing into the neighborhood.
- Encourage adjacent property owners to replace the solid wooden fence with wrought-iron, or similar semi-transparent fencing, thereby providing them with visual access to the park space which will lead to informal surveillance of the park, making it safer and less isolated.

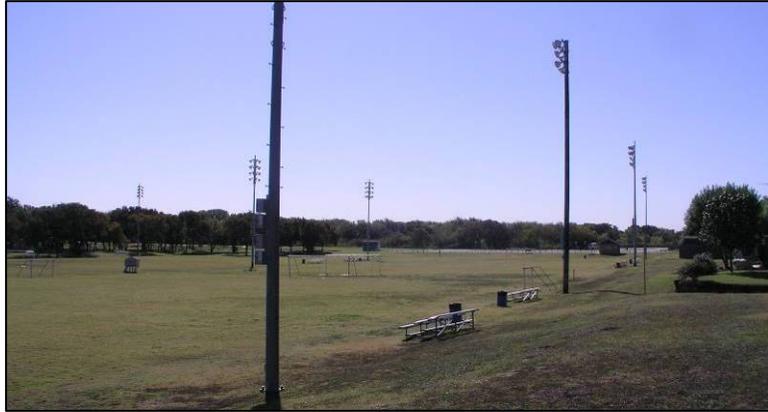
Comments – This facility enjoys good adjacency from surrounding pieces of land that help to define the park’s character and improve its visibility. On one side there is a wooded area, on another there is a wooded creek corridor, on another a road with parkland on the other side, and finally one side is

bordered by a residential area. Rather than the houses backing up to the park, however, the streets run perpendicular to the site and their ends are open to the park which allows for transparency and easy access from the neighborhood.

In its current state, this park provides little active use to its neighbors because the use of the soccer fields is restricted to league use and there are few facilities that are otherwise available. Even passive use by neighbors is restricted as there are no walking paths or other basic amenities such as benches or picnic tables.

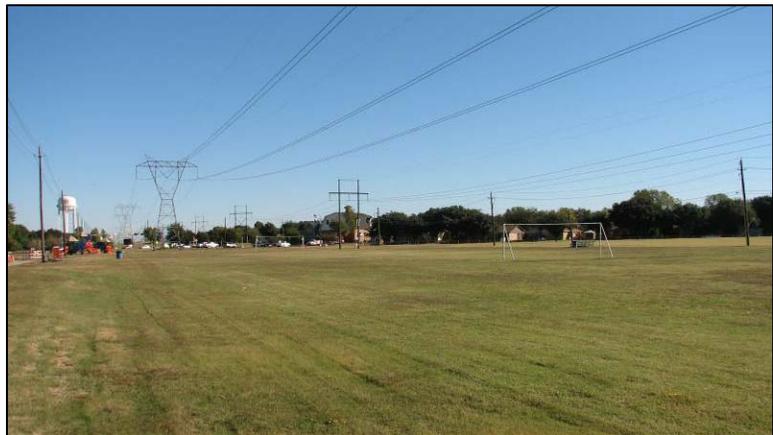
Comments – Camey Park is one of four parks near the intersection of Blair Oaks Drive and South Colony Boulevard. It appears to be very underutilized as the two soccer fields are not properly striped, one field has only one goal, and none of the goals have netting. As there is nothing else in the park other than one set of bleachers and two trash cans, this park does not function as much more than open space in its current state.

The most obvious distraction, both visual and audio, is the overhead power transmission lines.

- The soccer fields need much attention to be usable including striping, updated or repaired goals, and netting.

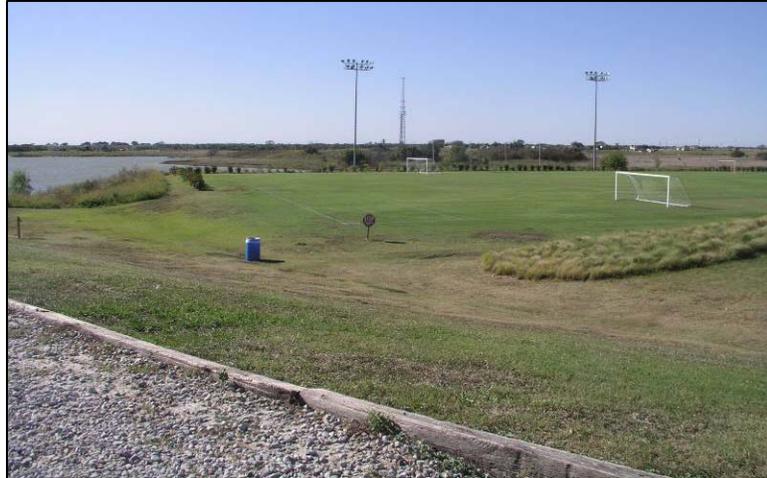
Comments – The Eastvale Park / Blue Sky Sports Center complex is located on a geographically unique peninsula which provides a high ratio of shoreline access to land area. Presently, the park itself is a dichotomy – the half closer to Main Street is the location of the well-maintained Blue Sky Sports Center with its new indoor soccer building and its three manicured outdoor soccer fields while the other half of the park is overgrown and decaying. In this half of the park there exist parking lots, a boat ramp, abandoned restrooms, an abandoned water well, and picnic areas that are completely

underutilized and/or in disrepair. The road leading to this portion of the park is overgrown, with approximately half of the width of the road being overtaken by grass.

- Access to the underutilized half of the park should be restored and improved.
- The existing boat ramp should be replaced with one that meets modern boat launching standards
- The picnic area should be restored for daily use by park visitors and shade should be provided, either through the use of shade trees or shade structures, for some of the picnic tables.
- The restroom building should be either completely renovated or removed.
- There is potential for short walking trails along the end of the peninsula.

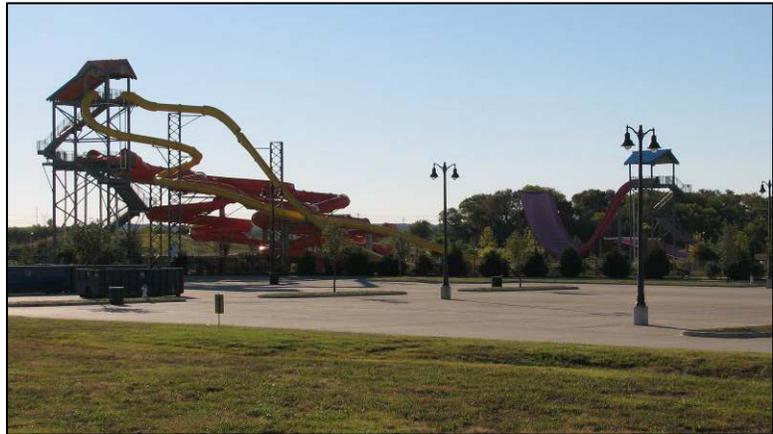
Comments – Though technically the same park, there are essentially two parks on this site – one is the existing Hawaiian Falls water park and the other is the currently undeveloped (but future) civic/recreation center. This park benefits from being surrounded by single-loaded roads on all sides which improves its visibility, though, two of these roads (Memorial Drive and Paige Road are medium to high traffic roads).

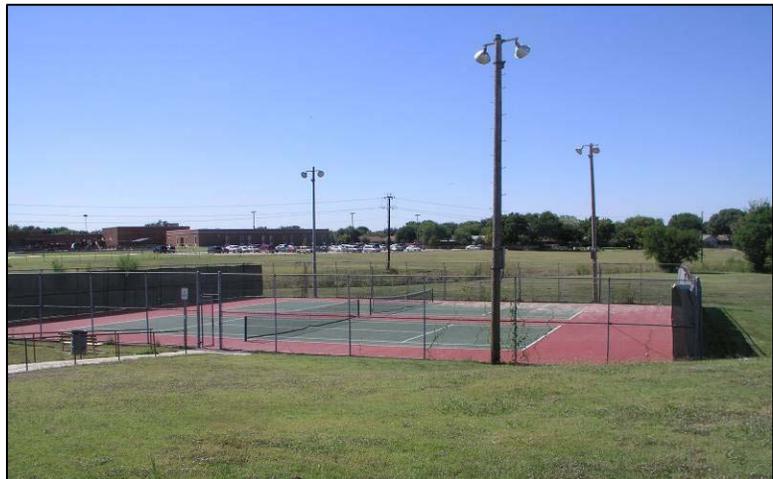
Comments – This park serves the function of housing the city’s only public tennis courts. The park also contains a baseball field and is adjacent to a middle school (and its football field) and an elementary school. Both the tennis courts and the baseball field are aged, but are visibly well-

maintained. The baseball field has two new shade structures for spectator seating. There is a drainage way which runs along the southern edge of the park and is the location of the only vegetation (other than mown turf grass) in the park. A good portion of this park is located underneath the large transmission lines. The edges of the park are not well defined, other than the single-loaded road adjacency on the east side of the park.

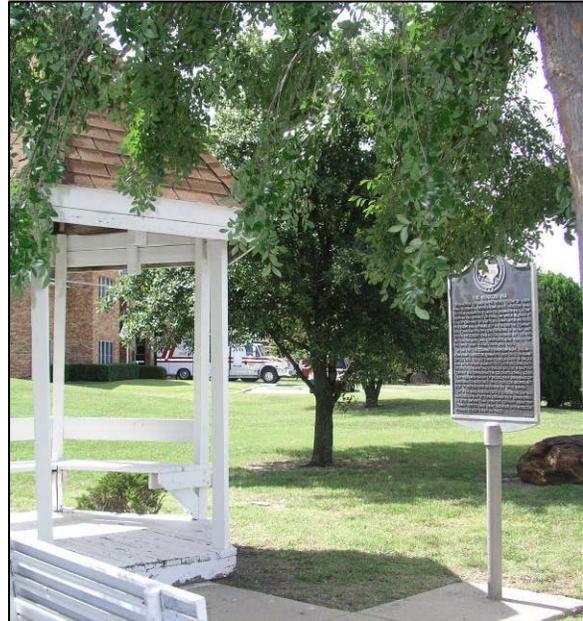
Comments – One of the four parks at the South Colony Boulevard / Blair Oaks Drive intersection, Historical Park is the oldest park in The Colony. Positioned on a small corner of land directly adjacent to the fire station, this park fits the definition of a pocket park due to its size. However, because of its small size and lack of active amenities, this park is probably not used very often and serves more as additional open space than as a location for active recreation (although this park is consistently a key starting/ending point for parades and is the host site for the Christmas Spectacular).

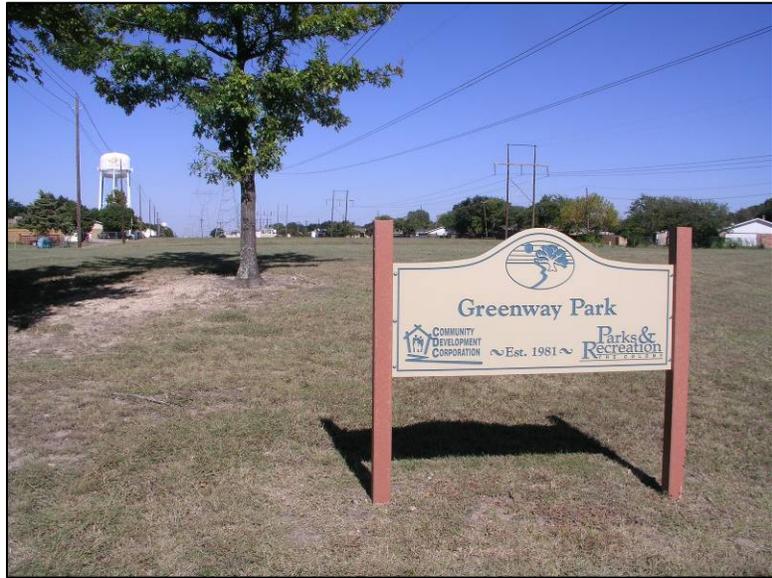
Comments – One of the four parks at the South Colony Boulevard / Blair Oaks Drive intersection, Greenway Park is impacted by the same issues as the others: visual and audible nuisances from the nearby streets and power lines. The visibility of the park does benefit, however, from the single-loaded road adjacency and the overall character of the park is improved by the adjacency of a creek, though this creek has not been allowed to exist in its natural state.

The park itself consists of a handful of semi-mature trees and a monument dedicating the park. Other than this, the park is currently undeveloped, though a historic Denton County bridge is slated to be moved to this location.

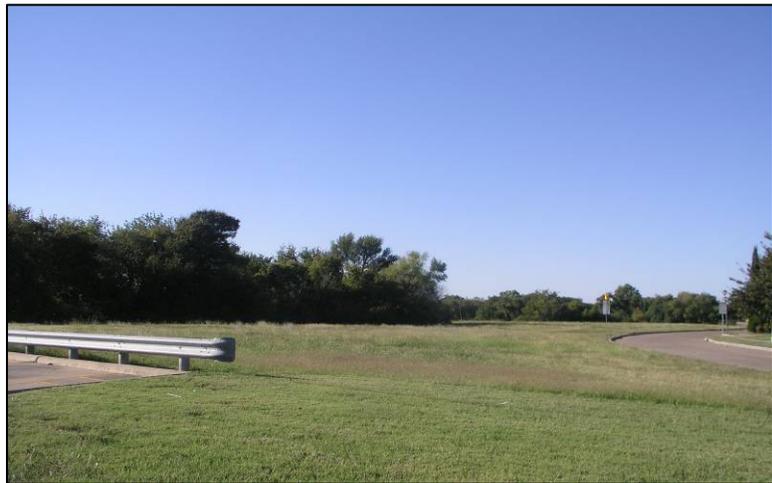
Comments – This park is currently undeveloped. The land to be occupied by this park consists of a linear open area bounded by a wooded ravine (on LISD property) on two sides, a single-loaded street, and Stewart’s Creek Elementary School. In addition to the elementary school, there is also a middle school nearby. It appears that students from one or both of these schools often visit the wooded ravine, which is suggested by litter and the arrangement of rocks and logs as seating areas.

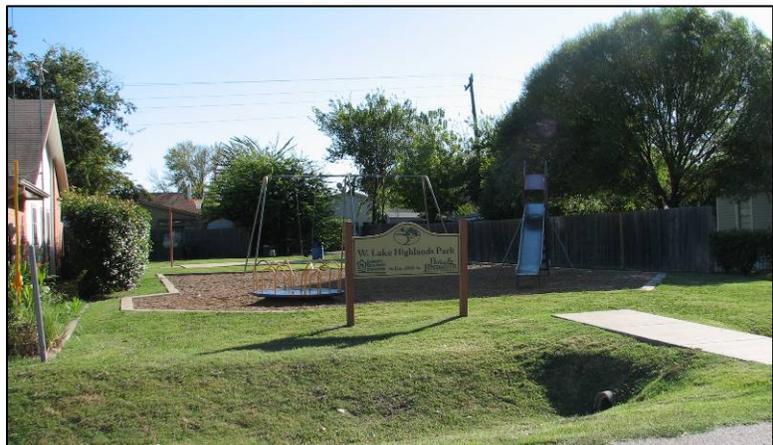
Comments – This tiny park situated on a standard 130’ by 50’ single-family house lot contains a playground and a basketball half court. These two amenities combined take up almost all of the usable space in this park, which most likely serves only the surrounding neighborhood, as no

parking is provided.

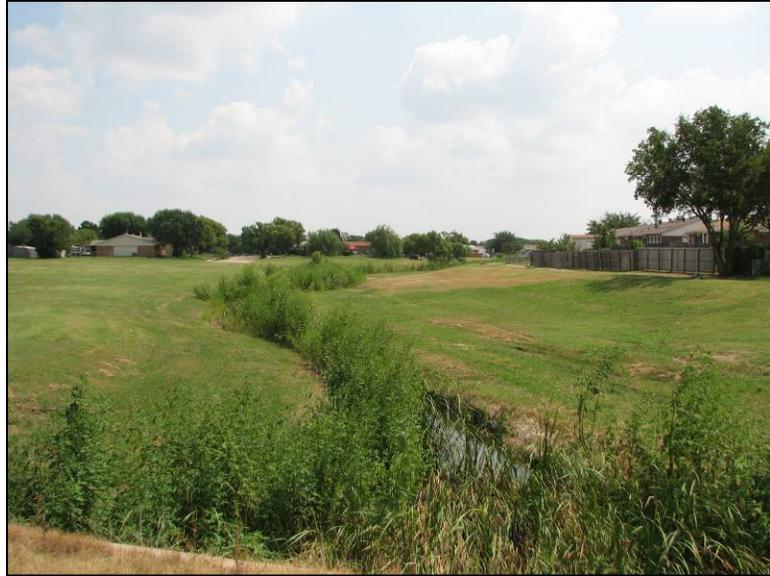
Comments – Perhaps the most unique and most notable characteristic of Taylor Street Park & Greenbelt is that it is The Colony’s only linear park or greenbelt – stretching approximately seven times longer than it is wide – other than the de facto linear parks created by the main utility easements crossing through the city. The park is surrounded by three types of adjacencies: single-loaded roads, alleys with garage access, and alleys with out garage access but having gate access into backyards. This park poses a great opportunity for The Colony, but in its current state is considerably under-utilized.

This park is lacking in three major areas; the first of these is the lack of an ADA-compliant network of sidewalks or pathways throughout the park. As in other parks, it is important to provide accessible pathways throughout the park to both provide access opportunities for all users but also to help bring organization to the programmed spaces within the park. The second issue area is vegetation within the park. Currently, the vast majority of vegetation is mown turf grass and there are few trees within the park. There exists a great opportunity to provide diverse, visually-stimulating areas of vegetation within the park that can also help to lower maintenance costs, reduce erosion, and improve property values of the surrounding neighborhoods. Finally, the park overall has an untidy appearance, largely due to the lack of vegetation and aged and inadequate facilities within the park. Specifically, the baseball diamond area could benefit from various repairs – the backstop and seating areas around the field need repairs and improvements and the white rock parking lot is pot-holed and poorly defined.

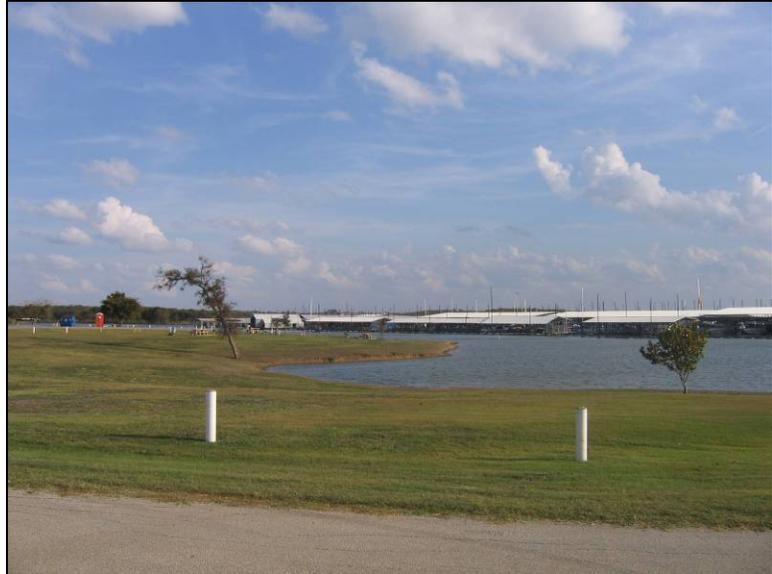
Comments – Stewart Creek Park is a mid-sized regional park located on Stewart Peninsula, making it a convenient location for many of The Colony’s citizens. The park offers several opportunities for day-use activities, including boating, fishing, and picnicking. While there are many facilities existing in the park, there is ample opportunity to add additional facilities which, as entrance to this park is fee-based, will help attract users to the park.

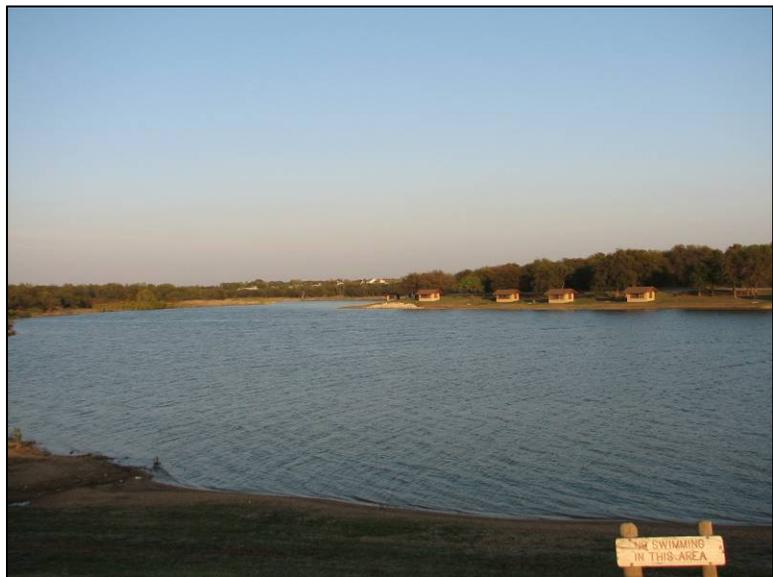
Comments – Formerly a State park, Hidden Cove is the largest and most diverse park in The Colony. It is located on land owned by the US Army Corps of Engineers, leased by The Colony, and subleased to MarineQuest, which operates the park. There are many day-use and overnight amenities in this park that provide visitors with many opportunities for recreation.

There currently are plans for the development of a marina by MarineQuest at this park.

- Many of the park’s amenities required repairs after the flooding in 2007. To prevent damage to future amenities, they should be flood resistant and/or placed at a high enough elevation that they will not be flooded.

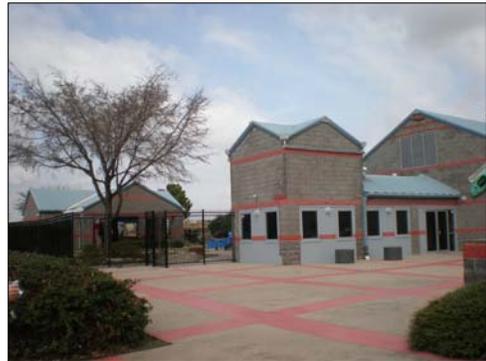
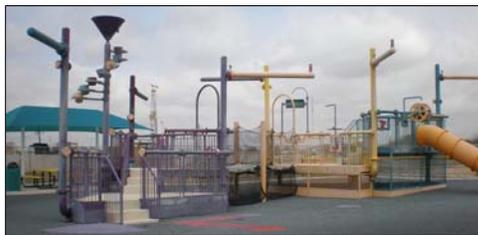
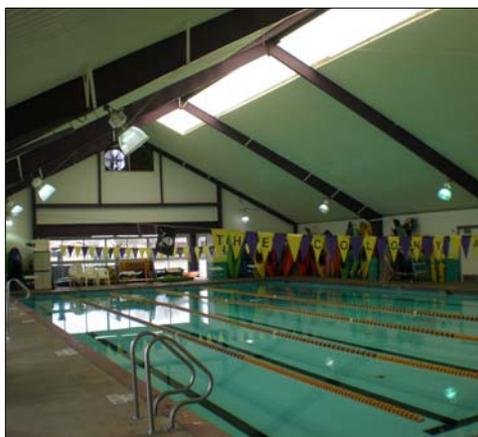
Comments – The Aquatic Park dates from 1986 and has evolved over time. It is the city’s only municipal pool and is therefore the flagship water venue, aside of course from the lake. It is well-used and has grown in capacity and offerings since it opened. The “Spray Zone!” is a relative new component, but is showing signs of age due to faded finish. Relatively new “dry” amenities include sand volleyball, and additional shade areas. Pride of ownership is apparent in the overall cleanliness and organization of the facility. Colorful and artistic murals within the buildings show similar evidence. These additions have maintained a sense of newness for the venue over time and have served the facility well. The enclosed pool is heated to serve the community year-round. It is not a truly indoor pool as it does not

offer air conditioned space. In the summer season, it is opened up and relies primarily on natural ventilation to maintain comfort.

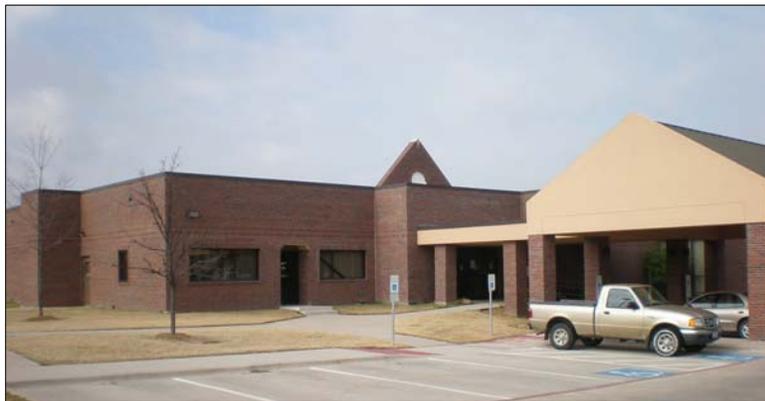
Comments – This building is the former city library. It was renovated in approximately 2002 to house the Senior Center and Parks Administrative offices. The Senior Center comprises approximately 2/3 of the building, leaving approximately 1/3 for administration. Of the

buildings toured, this one appears to be the newest. It is certainly the most recently renovated. It appears to be in generally good repair and to be well-maintained. A sense of pride in ownership is obvious among staff and patrons. The facility shares parking with the police station and recreation center. Anecdotal comments on the tour seem to indicate adequate parking for the current use.

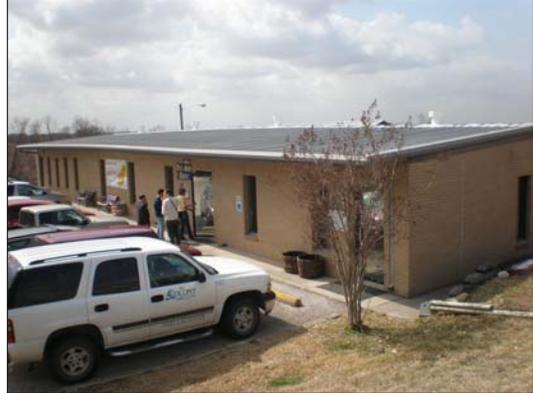
The structure itself is a manufactured metal building clad on three sides by brick. It appears to be structurally sound. It has a very low roof, making for correspondingly low ceilings in the rooms. The structure of the wing is wood-framed and in poor condition, especially at the “connector” piece between main building and wing. The ad hoc nature of the layers of addition/renovation work makes the quality and adherence to codes and standards something that should be reviewed in detail. Finishes have exceeded their life spans. Equipment was not evaluated, but general observations hold little optimism for their longevity or fitness either. The flexibility of the theatre group to make use of the space is remarkable. Their pride of ownership is obvious despite the nature of the building having little to do with their practical needs.

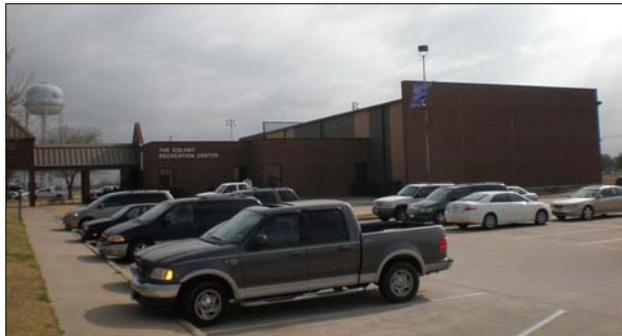
The building consists of a manufactured steel-frame building (the gymnasium) with brick cladding on most sides and an addition wrapping about 35% of the perimeter. About half of the total enclosed area is the gym. There is also an 800 SF exterior courtyard off of the front meeting room. Other functional spaces include a multi-purpose room (a converted weight room), two racquetball courts, game room, a small office area, control desk, public toilets and separate locker rooms with toilets and showers.

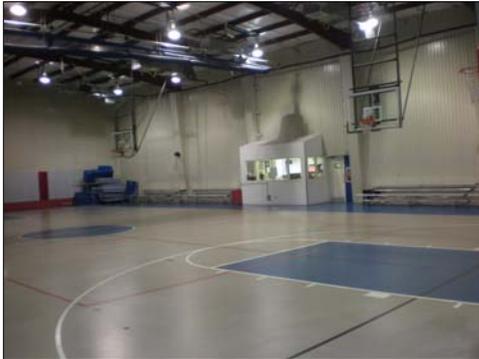
The gymnasium provides a full-court basketball field of play, dividable by curtain into two smaller courts (for a total of six basketball goals). It is also striped for volleyball. The synthetic flooring provides for multi-purpose programming well beyond typical ball-court play. Minor seating capacity is provided with “tip-n-roll” bleachers. Dedicated gym storage is not available, so perimeter deck space is cluttered with various gym appurtenances. Lighting and air
